TM 941159

TECHNICAL MEMORANDUM

WEAR TEST RESULTS OF
CANDIDATE MATERIALS FOR THE
OK-542 TOWED ARRAY HANDLING MACHINE
LEVEL WINDER

Date: 29 December 1994

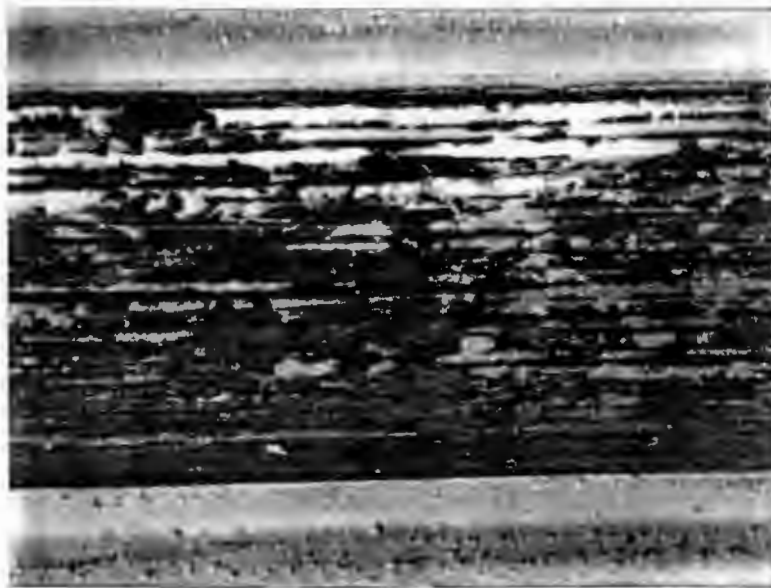
Figure 8. C71500 Copper-Nickel Wheel/ Clad Inconel 625 (10X)

Figures 7 through 14 depict the weld-clad samples and the wheel surfaces that were in contact with them. On Figures 9 and 10, the galling of the Monel is visible. As noted, this occurred in a relatively short period of time. Although there is no photograph available to support the appearance of the wheel, it, too, showed similar wear characteristics. On both parts, it appeared that metal had been peened over, it was shiny and rough to the touch. Figures 21 and 22 show the Titanium sample and wheel, respectively. The wheel used shows similar rough characteristics, but, the Titanium sample itself, does not.

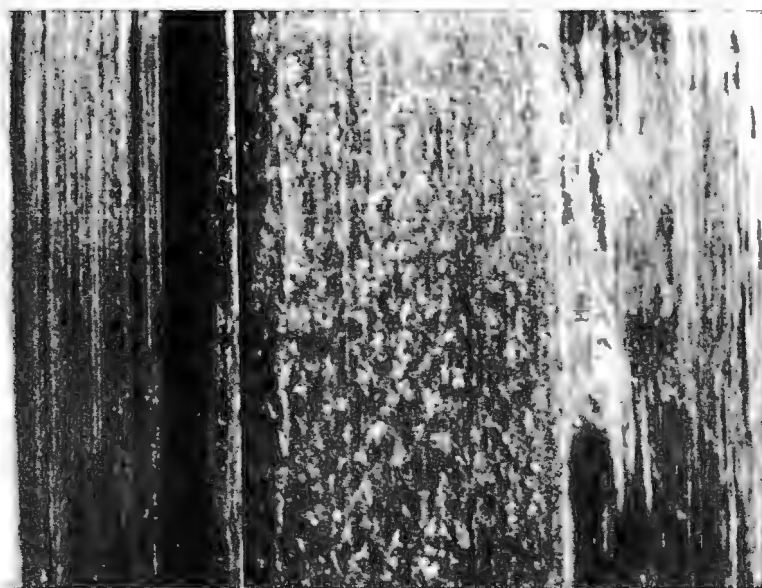
Figure 12. C71500 Copper-Nickel Wheel/ Clad Stainless (11.25X)

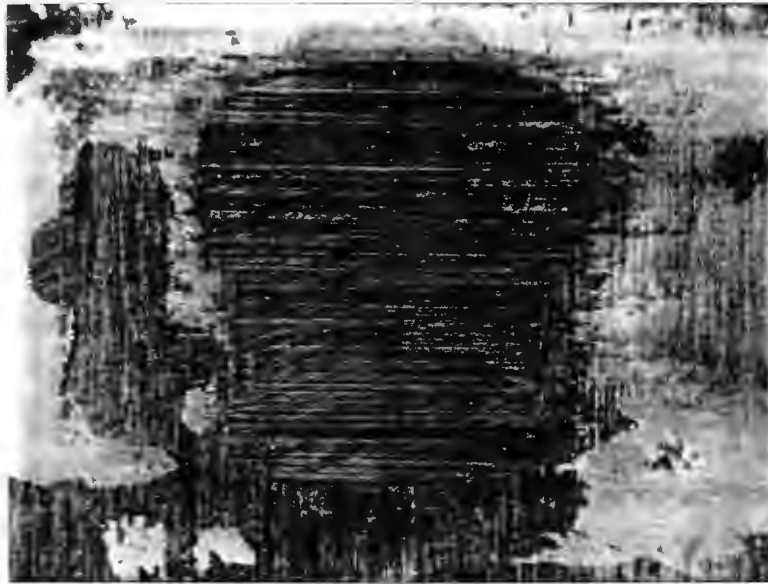
Figure 13. Clad Stellite (0.8X)

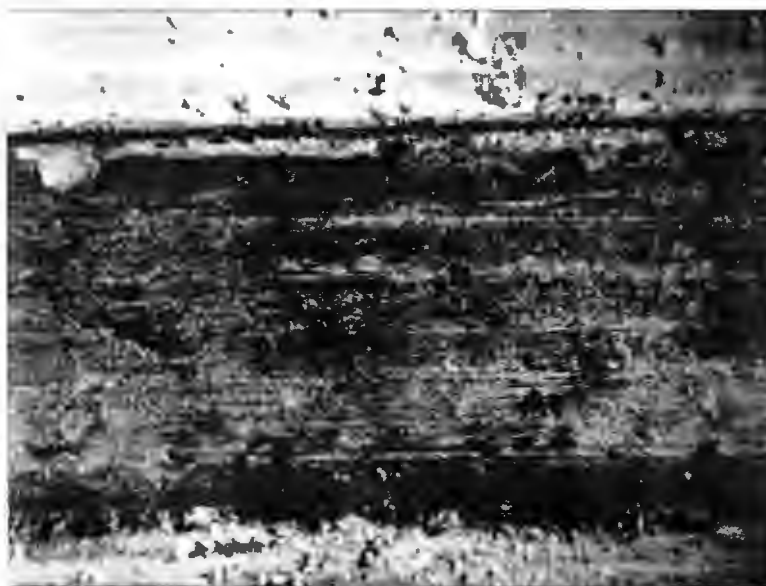
Figure 20. C71500 Copper-Nickel Wheel/ Inconel 625 Bar (10X)

Based on the testing and observations discussed herein, it seems that Inconel 625 bar stock is the best choice, both mechanically and economically. While both the cladding and bar forms indicate consistent and damage-tolerant behavior, weld cladding can be a labor-intensive operation adding cost to the part. Inconel 625, while extremely resistant to corrosion, is very strong mechanically and is readily available in bar form from local suppliers.

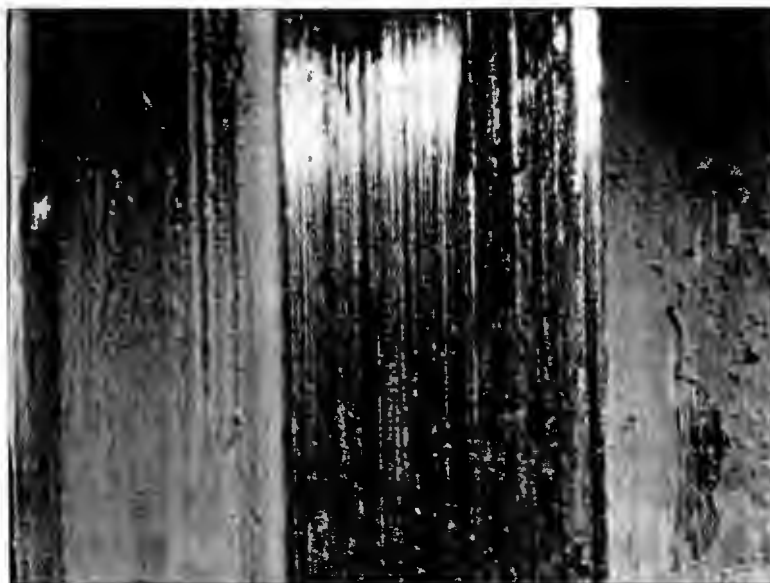
Figures 23, 24, 25 and 26 show the behavior of the Ni-Al-Br Pawl material in this test. the sample used was fabricated from and actual Pawl. Of all the samples tested, it showed the highest degree of wear.

Figure 23. C63000 Nickel-Aluminum-Bronze (Pawl Material, 10X)

Figure 24. C63000 Nickel-Aluminum-Bronze (Pawl Material, 2.5X)

Figure 25. C71500 Copper-Nickel Wheel/ C63000 Nickel-Aluminum-Bronze (2.5X)

Figure 26. C71500 Copper-Nickel Wheel/ C63000 Nickel-Aluminum-Bronze (15X)

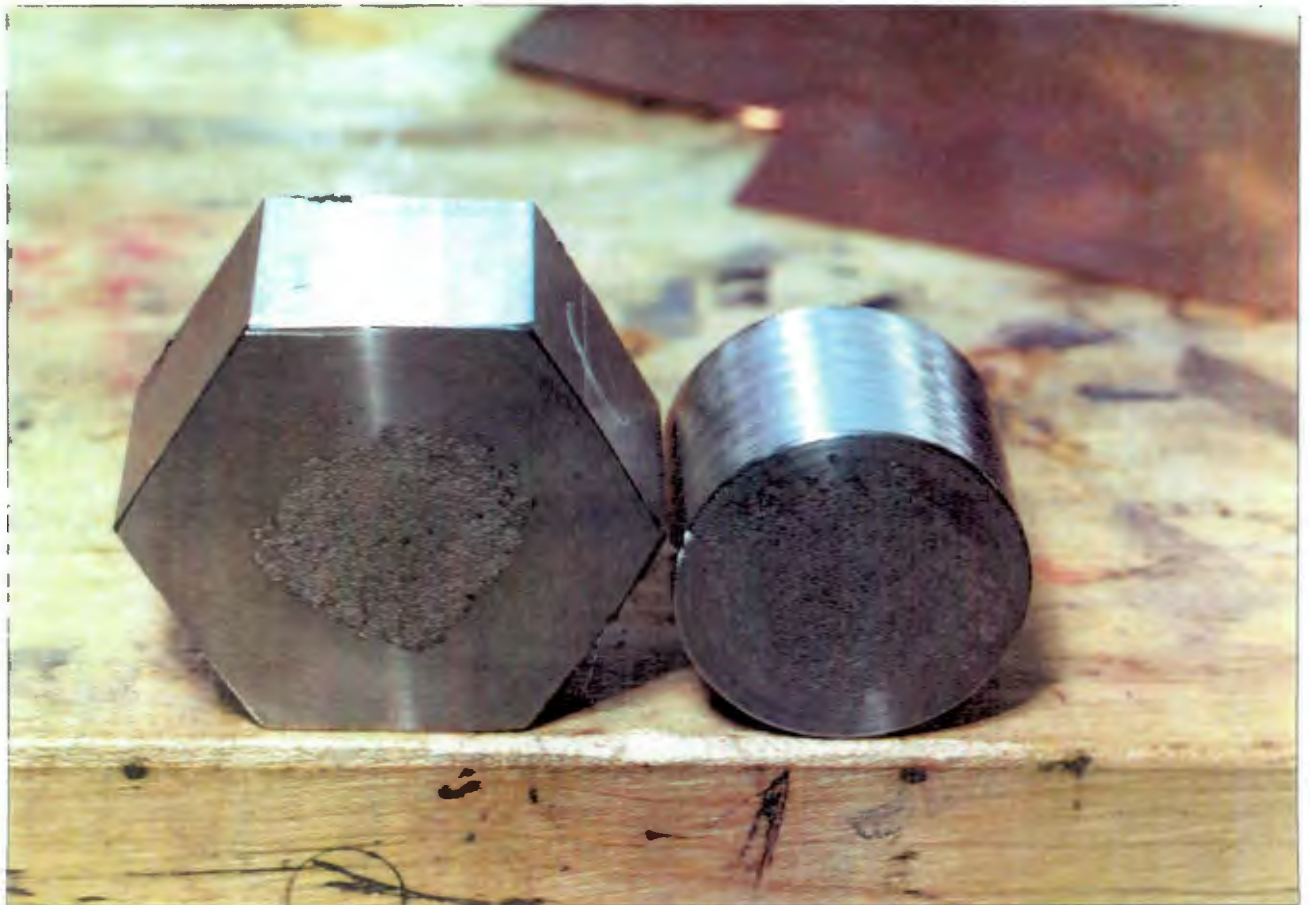
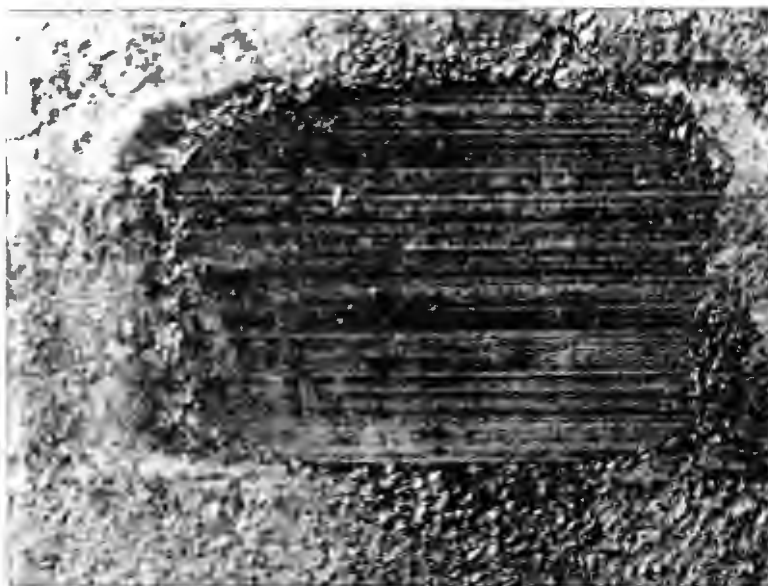
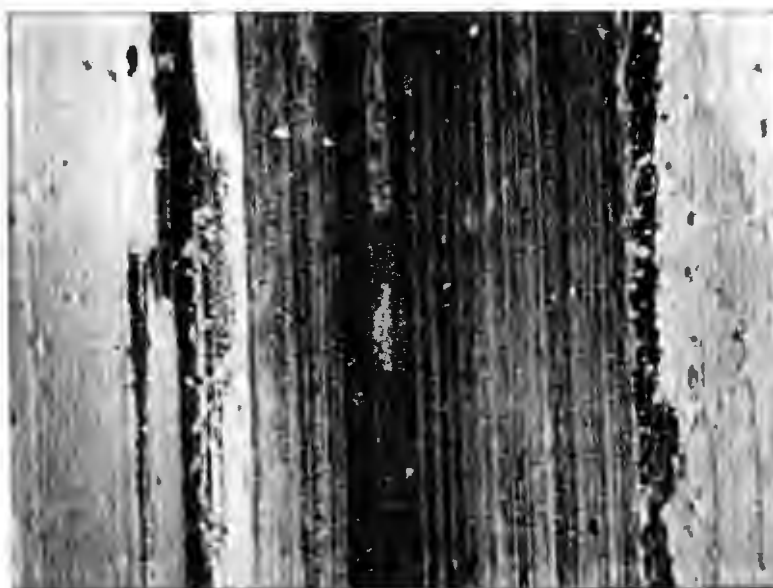
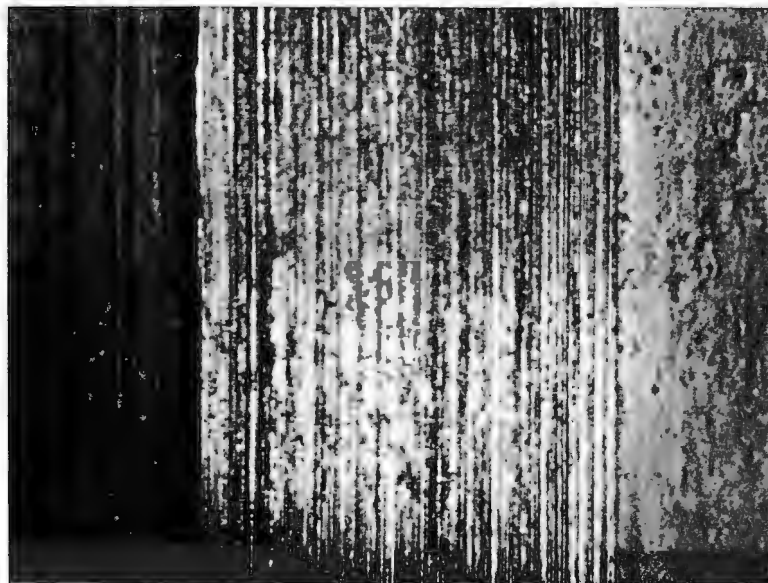
Figures 27 through 31 characterize the behavior of the Rocklinized samples. Each of the base materials was coated with approximately .002" of the carbide coating which was worn through. This coating was applied to the base metals cold; further information is contained in Appendix C.

Figure 27. Rocklinized Samples

Figure 28. Rocklinized Stainless (10X)

Figure 29. C71500 Copper-Nickel Wheel/ Rocklinized 316 Stainless (10X)

Figure 30. Rocklinized Inconel 625 (10X)

Figure 31. C71500 Copper-Nickel Wheel/ Rocklinized Inconel 625 (10X)
